DEPARTMENT OF TRANSPORTATION

Quality Assurance and Source Inspection

Contract #: 04-0120F4Cty: SF/ALA Rte: 80 PM: 13.2/13.9File #: 69.28**WELDING INSPECTION REPORT****Resident Engineer:** Pursell, Gary**Address:** 333 Burma Road**City:** Oakland, CA 94607**Report No:** WIR-012059**Date Inspected:** 29-Jan-2010**Project Name:** SAS Superstructure**OSM Arrival Time:** 700**Prime Contractor:** American Bridge/Fluor Enterprises, a JV**OSM Departure Time:** 1900**Contractor:** Zhenhua Port Machinery Company, Ltd (ZPMC), Changxing Island **Location:** Shanghai, China

Bridge No: 34-0006**Component:** Tower**Summary of Items Observed:**

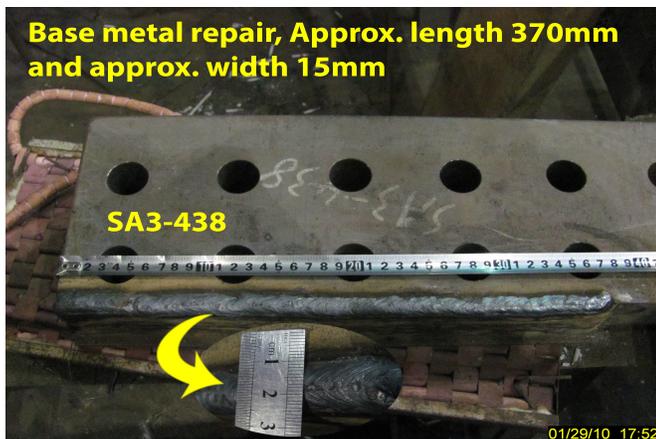
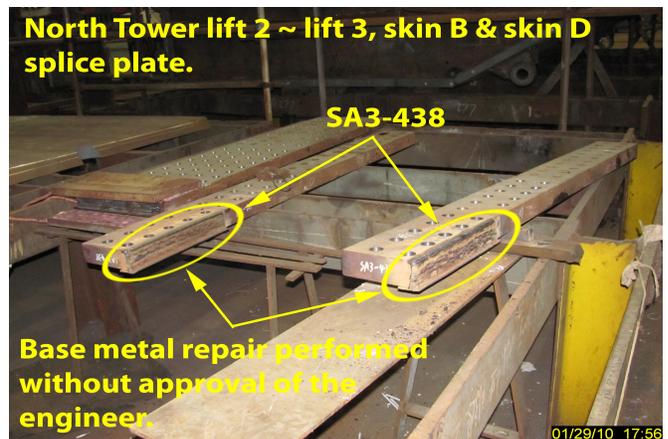
During random in-process observations of the fabrication of North Tower lift2 ~ lift 3, skin B & skin D splice plates, this Quality Assurance (QA) inspector observed the deposition of weld metal (buttering/build up) by Shielded Metal Arc Welding (SMAW) process on the base metal edge of splice plates for skin B and skin D of North Tower lift 2 ~ lift 3. This base metal repair was performed without the approval of the Engineer. This build up was performed across the entire width of the edge and measured approximately 15mm thick and approximately 370mm in length. The material thickness is 60mm. The members are both identified as SA3-438. The members are located in Tower Bay 10.
